DEFENDANTS' RULE 26 REPORT

June 29, 2018

**Re: Patrick Pete Stover and
Sheri Lynn Stover, Plaintiffs
v.
State Farm Fire and Casualty
Company, a foreign for-profit
insurance corporation,
Defendant
United States District Court o
Western District of Oklahoma
Case No.: CIV-17-1002-HE**

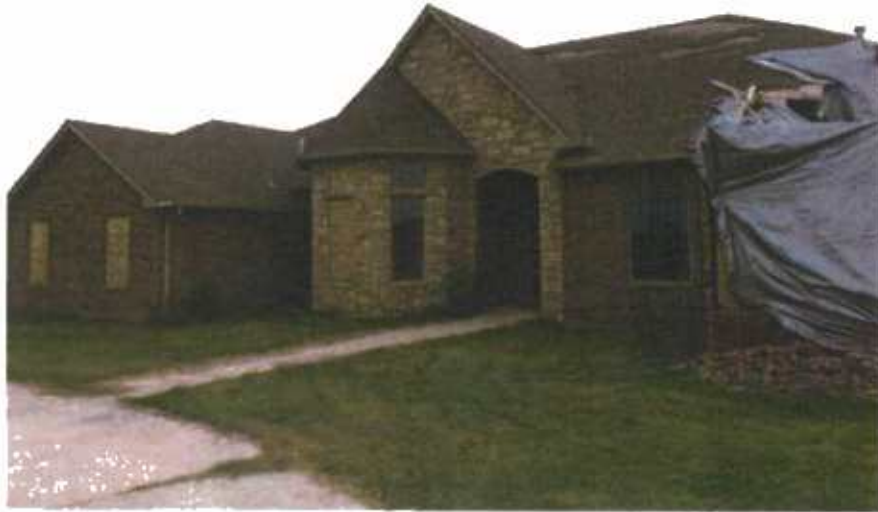
Photo 1: Front of the subject property

The subject property is a two (2) level, single family, residential structure owned by the Stovers. Based upon information and belief, the home was built in 2012 and has approximately 5,416 SF of living area. It is constructed with dimensional wood framing and utilizes a cast-in-place concrete foundation and slab-on-grade. The windows are single-hung, insulated vinyl units. The exterior cladding of the home consists of brick and rock masonry veneer with some wood product siding and architectural treatments. The roof system is a laminated, composition shingle overlaying an oriented strand board (OSB) deck. Generally, the house faces south.

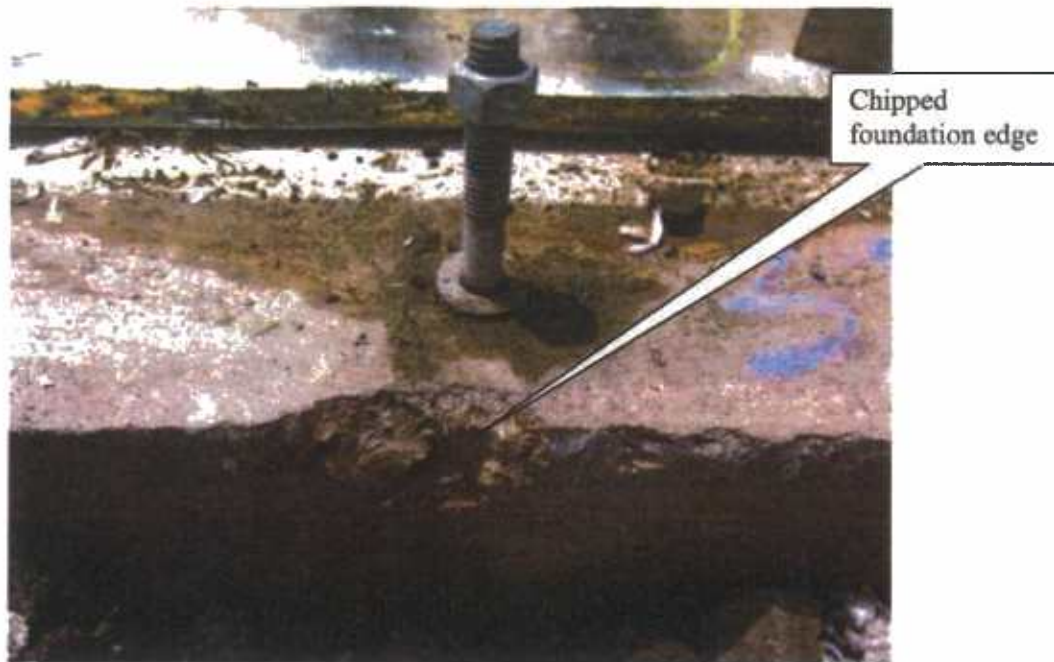
1.1.3. *He believed he observed slab and anchor bolt damage at the southeast corner of the residence.* I conducted a closer inspection of the same area and determined that the home's anchor bolts were undamaged.

- One surface shrinkage crack and some chipping of the leading edge of the slab were noted in a few places at the southeast corner of the slab.
- There is evidence that some of the chipping was likely induced at the time of original construction methods, e.g. there is evidence that concrete nails were used to fasten the framing bottom plate to the slab at the fracture point.
- The aberrations are cosmetic and of no consequence in the future performance of the foundation. They can be repaired using conventional concrete restoration methods.
- They will be concealed from view once the home is repaired and they are incorporated into the finished wall assembly.

1.1.4. *A detailed inspection of the concrete slab should be performed when the floor finishes are exposed to view.* This is often routine in the restoration
